# Inspection Report

**Property Address:**  
123 Main St  
Midcoast Town Maine 04000

**Long Cove Inspections LLC**

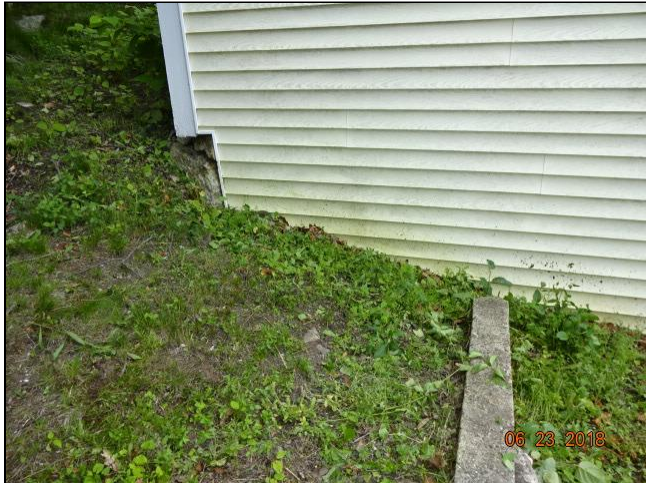
1.2 Item 1(Picture)

⛔ The grade at the rear and sides of both the house and barn should be lowered and graded to divert water. The sills are currently below grade in many areas.

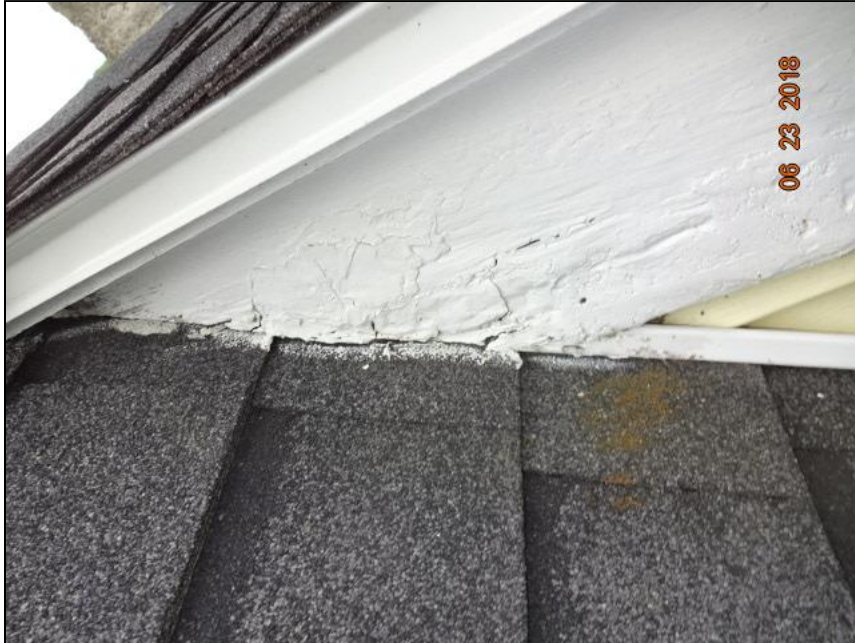
⊘ Damaged wood trim was observed at relatively few locations. Recent paint and putty may conceal other areas.

1.3 Item 1(Picture) rake board at flat roof

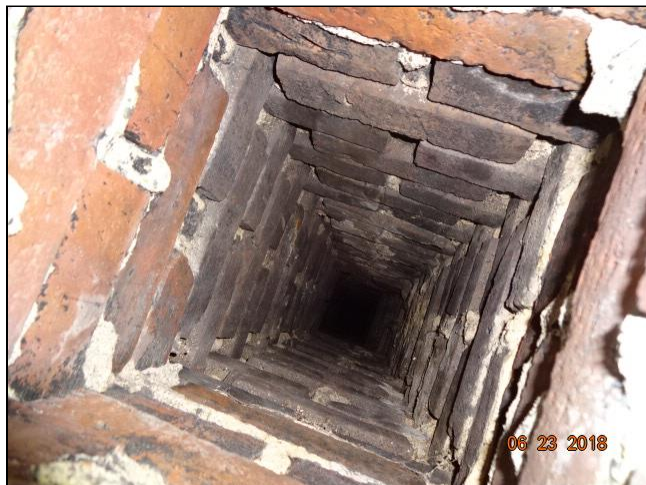
1.7 Item 1(Picture)

⊘ All four brick chimneys are unlined and weathered. Two serve as flues for oil fired furnaces and should be lined.

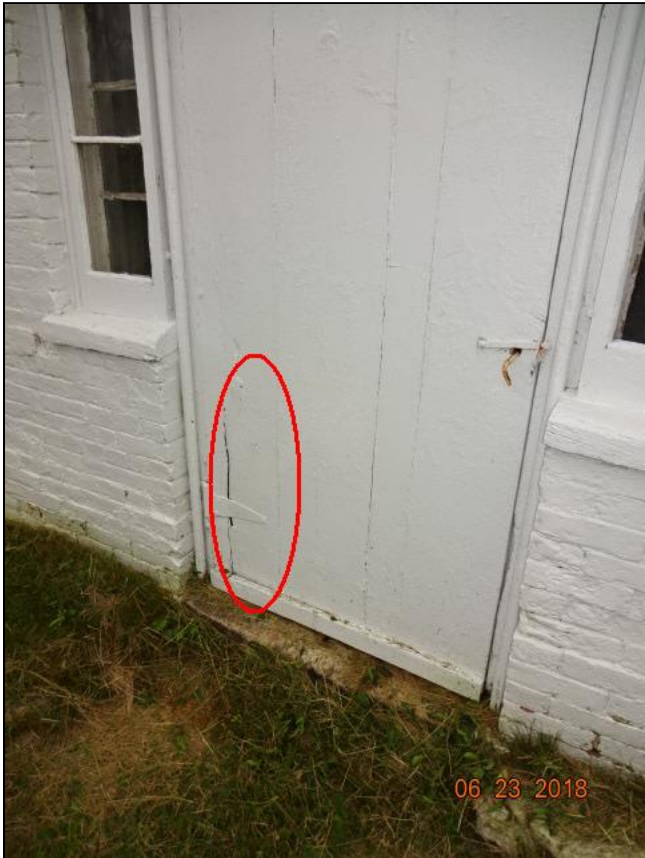
2.0 Item 1(Picture)

⛔ All six exterior doors require varying amounts of repair or adjustment. The entry unit with sidelights at the south side is in poor condition.

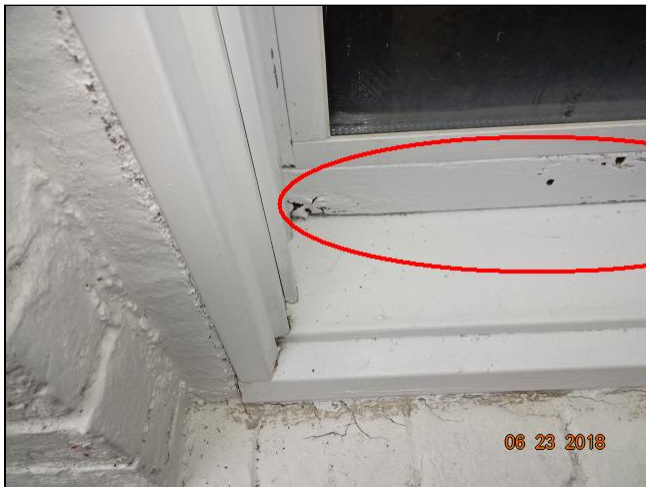
2.1 Item 1(Picture)

🔧 Several window sash particularly on the lowest level are showing signs of decay.

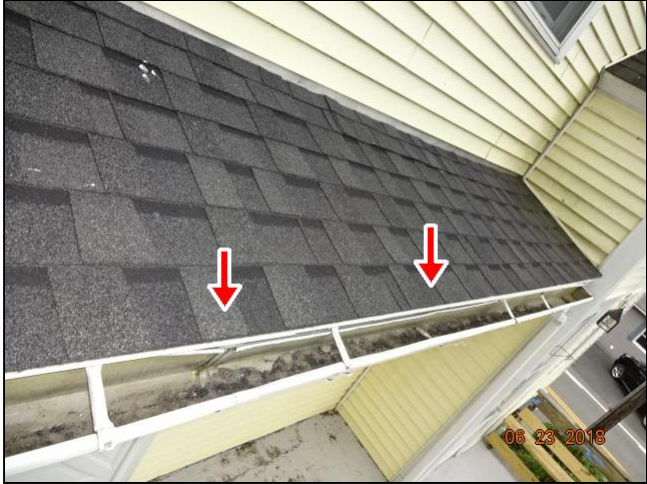
3.2 Item 1(Picture)

The gutter over the patio has some broken supports and needs cleaning. Additional guttering, particularly over the patio area and across the rear of the building is strongly recommended.

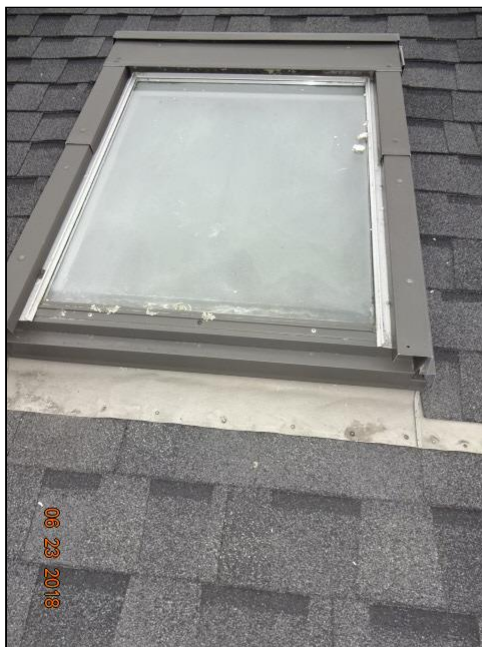
3.5 Item 1(Picture)

⊘ The glass in the skylight has a fogged seal.

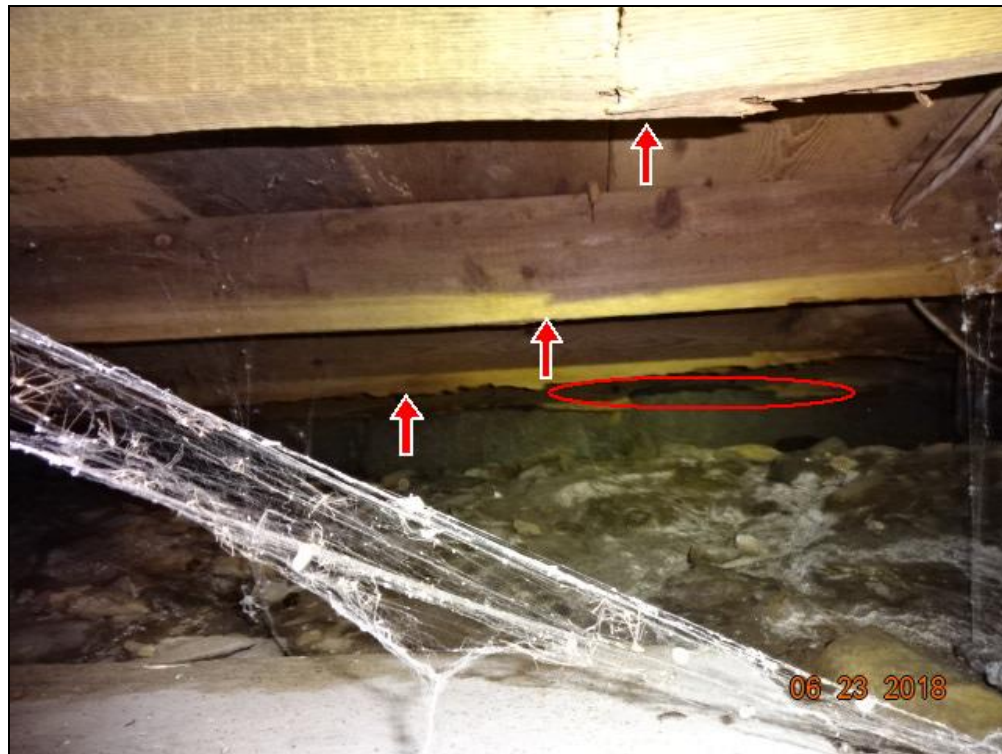
⊘ Although the joist system is generally in good condition for a building of this age, some damage to the floor joists and sills is suspected at the uphill end of the building. I could not get close enough to verify this but did take some pictures.

4.1 Item 1(Picture) damaged joists and possible bad sill (circled)

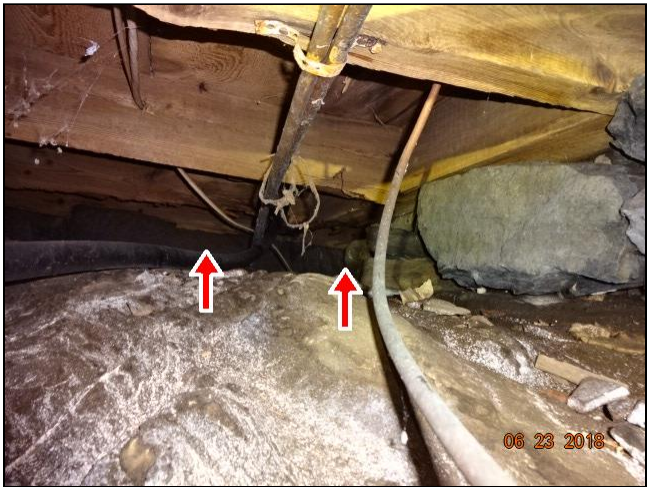
4.1 Item 2(Picture) area of suspected sill and beam damage.

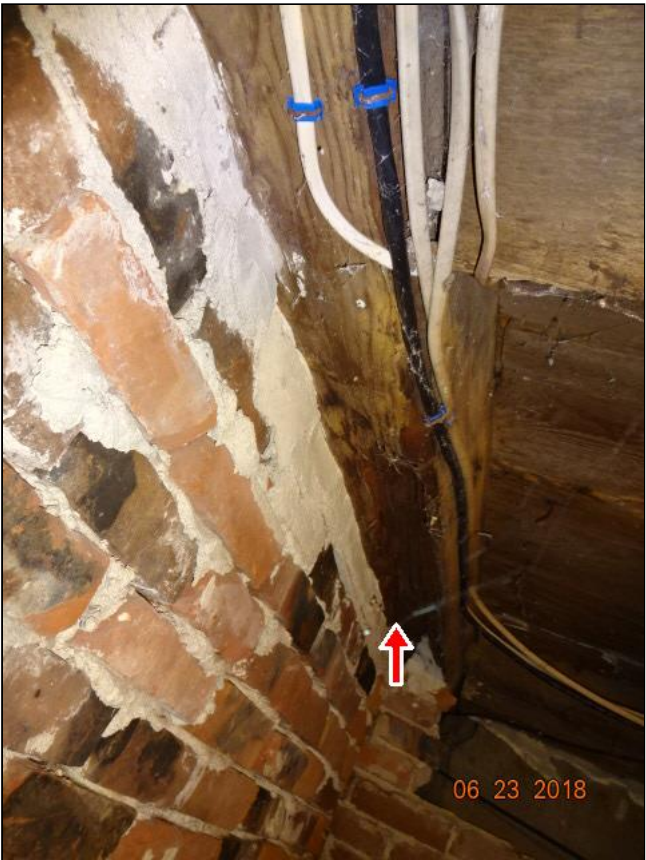
4.1 Item 3(Picture) old sill damage just inside crawl

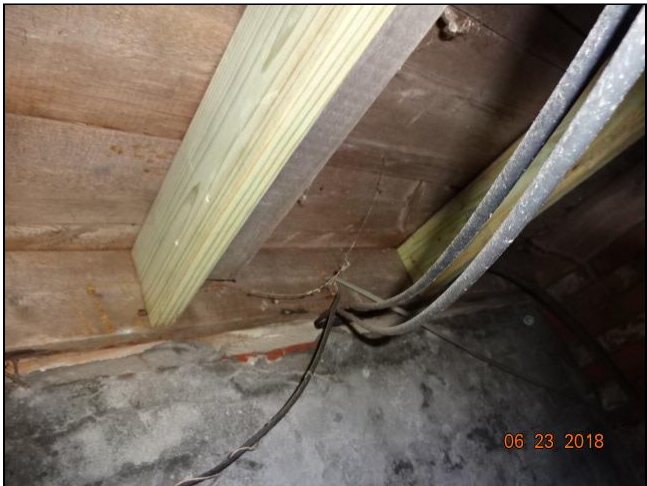
The southern covered entry has had repairs carried out underneath but the integrity of the southeast corner is questionable.

4.1 Item 4(Picture) under entry

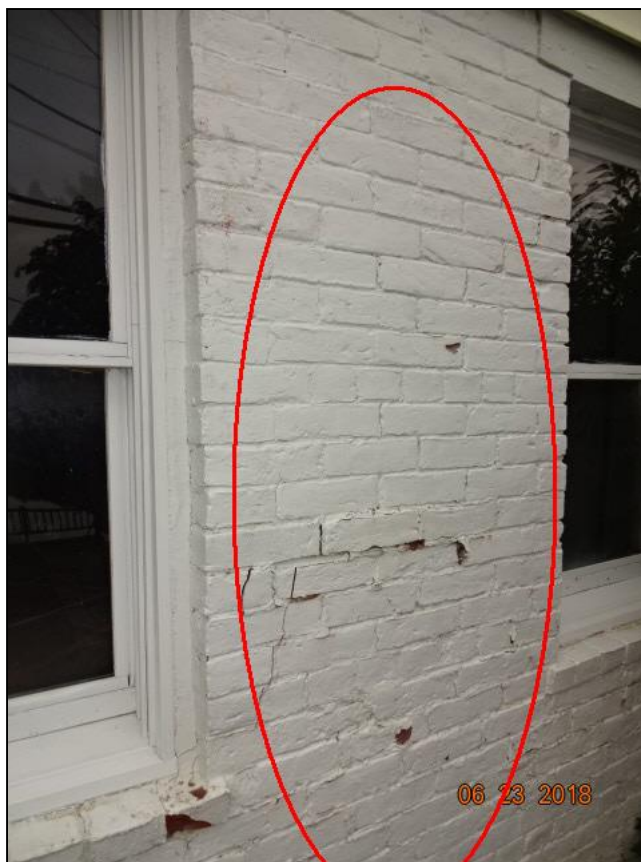
4.3 Item 1(Picture)

⊘ A series of cracks was noted in the brick wall at the lowest level. Repairs by a mason with experience in old buildings is advised.

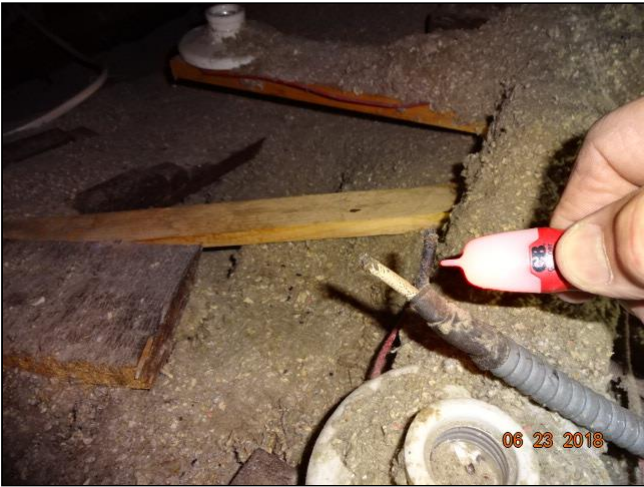
5.4 Item 1(Picture)

⚠ My tester indicated an exposed live wire just inside the hatch.

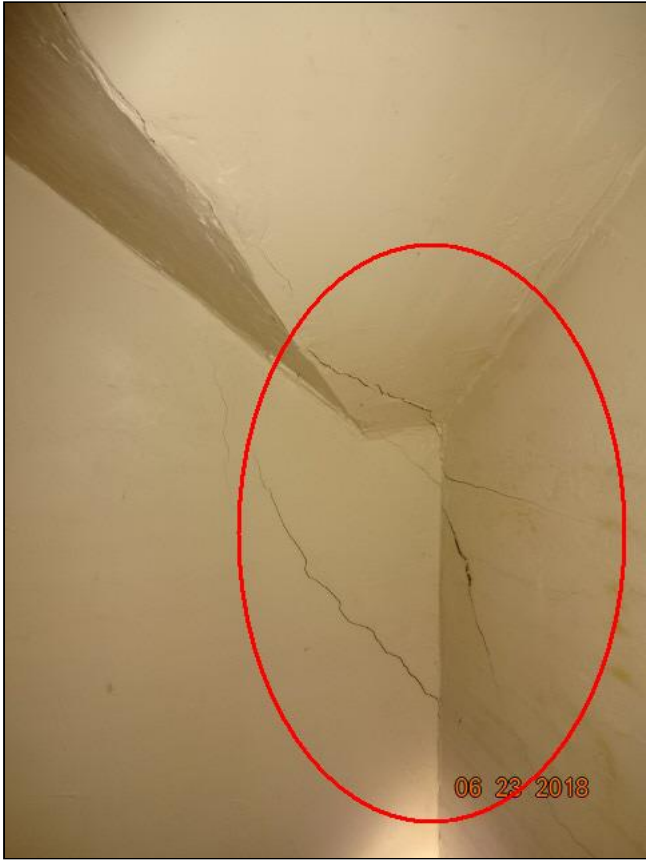
6.1 Item 1(Picture)

🔍 Some cracking of plaster walls at the east end on the second floor may indicate settlement. Suspected sill damage below is in the same general area.

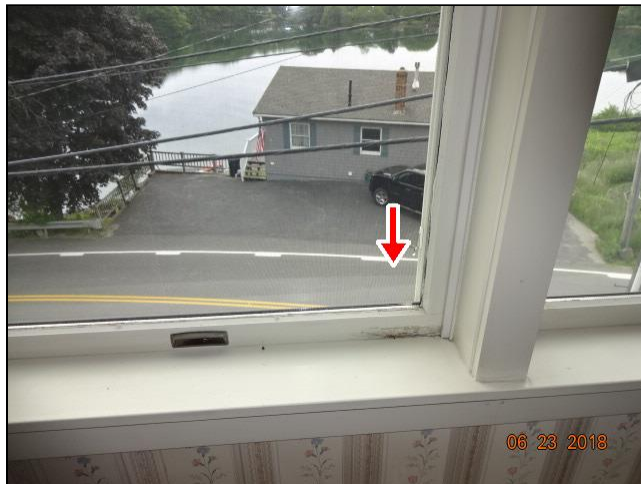
6.6 Item 1(Picture)

🔧 Windows on the east side are beginning to show decay at several locations. One sash has a fogged seal on the second floor.

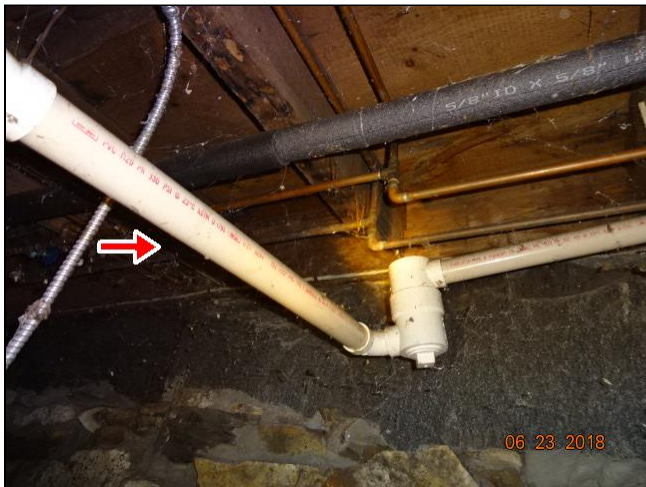
⊘ The washer drains are not compliant with modern codes: Both have low sections where water is retained at all time and the rear unit runs through plastic pipe about 20' and then uphill to a drum trap.

10.3 Item 1(Picture) direction of water flow front laundry drain

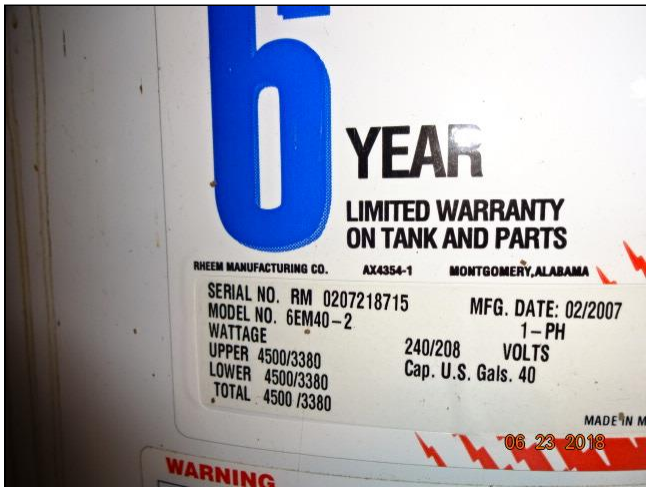
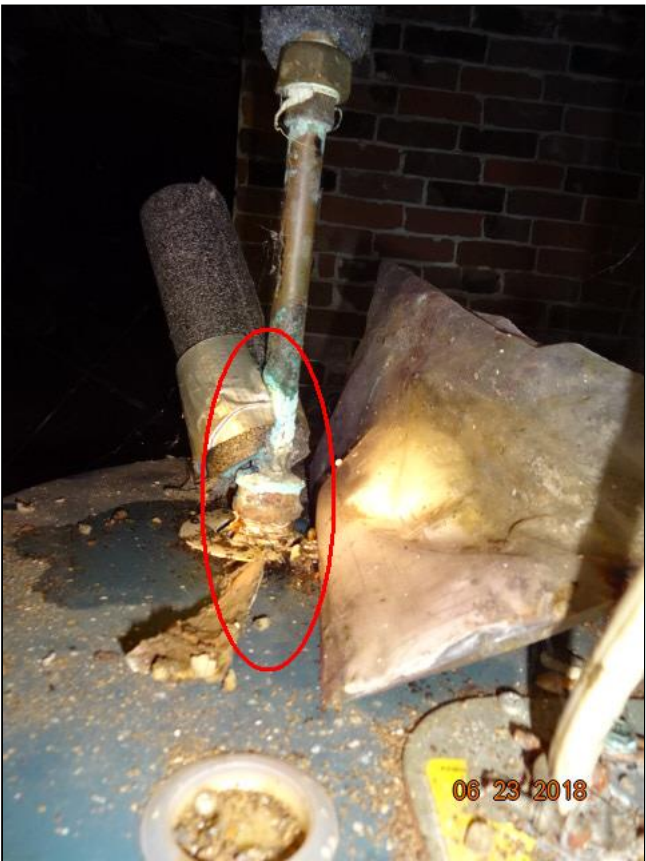
⊘ Each unit has an electric water heater. Both should have the relief piping extended closer to the floor. The Richmond heater with the six year warranty was installed in 2007 and shows signs of deterioration at the top. The other by US Craftsmen appears to be in good condition.

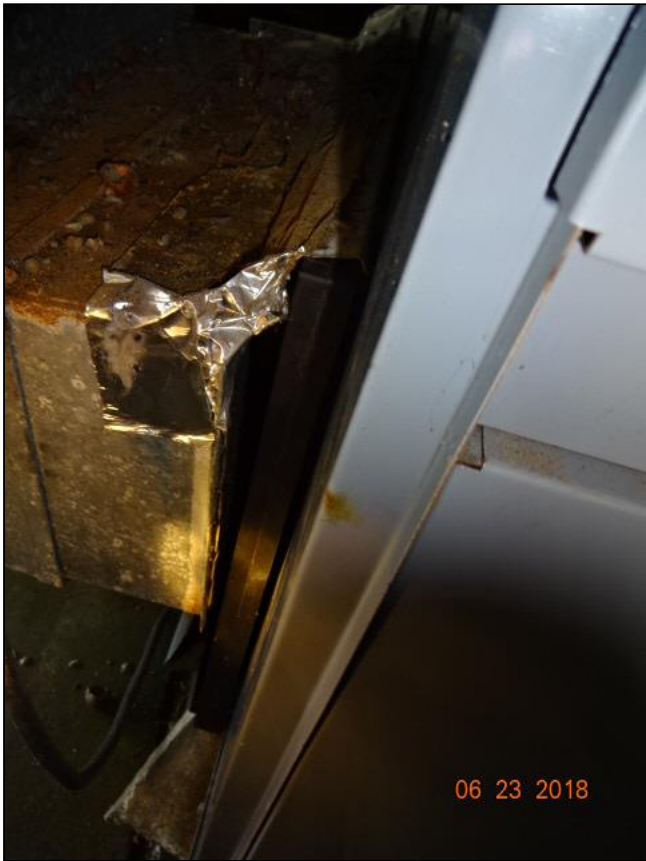
⊘ Two furnaces were tested: an older Williamson temp-o-matic in the rear unit and a recently installed 2011 Airco unit for the front. The Airco unit has a poorly crafted return air filter box. The Williamson unit is an older unit. I could not determine its age but Williamson went out of business in the 1990s. They made a great product but the age of the unit should be considered. I put a CO detector in front of a register at each unit and got no reading but a test by a certified heating tech is recommended.

11.0 Item 1(Picture) Airco return air filter

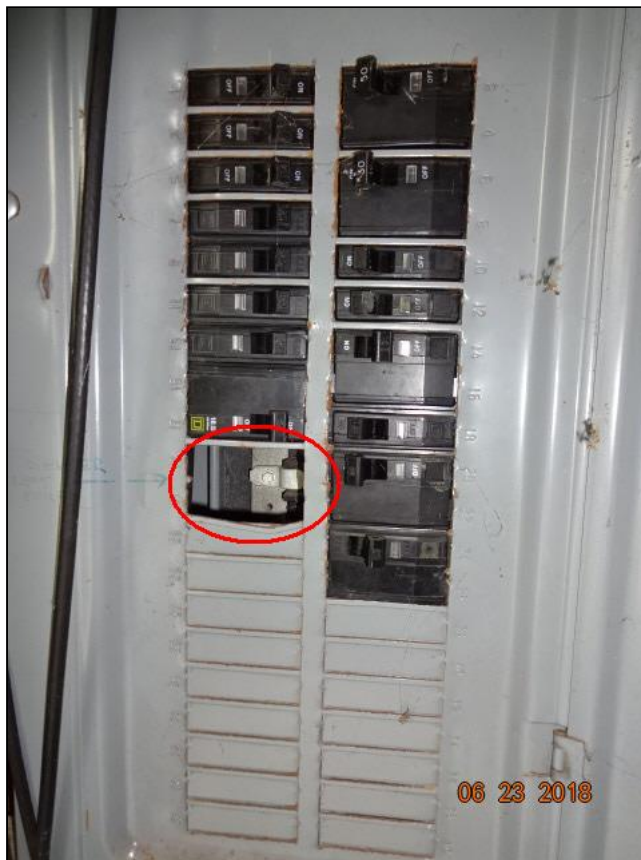
12.5 Item 1(Picture)

⊘ A blank cover needs to be installed where a breaker has been removed in the 200 amp service.

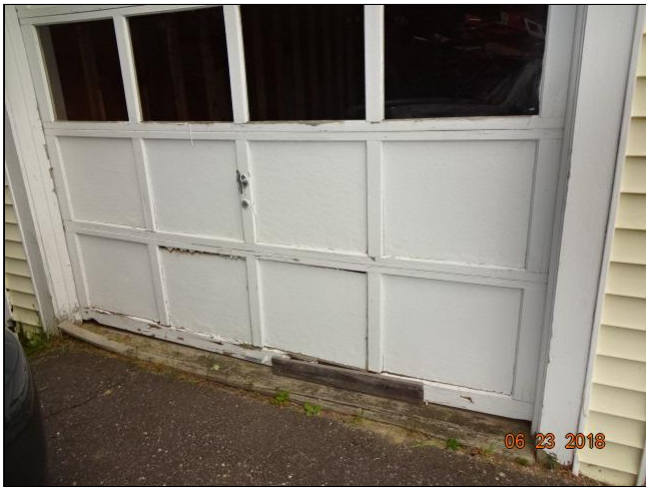
⛔ The doors need to be replaced.

14.0.A Item 1(Picture) damaged door (1 of 2)

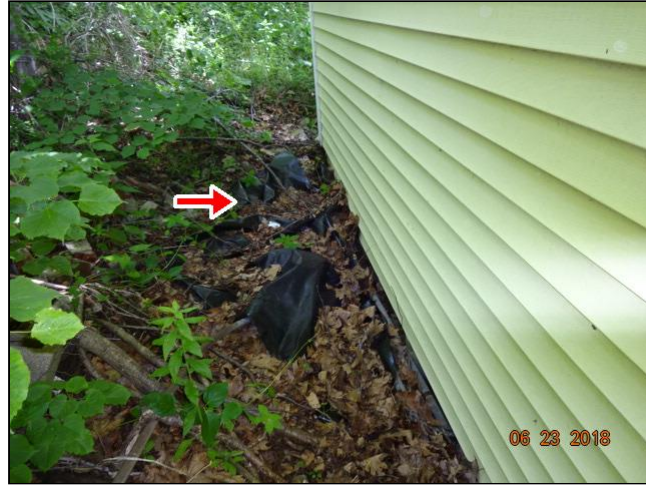
14.3.A Item 1(Picture)

🐿 The structure is in overall good condition, but the southeast corner is below grade. Excavation and re-grading is needed. It may be desirable to install a gutter and downspout on the east side to direct water away from the corner of the building. Overhanging trees should be cut away.

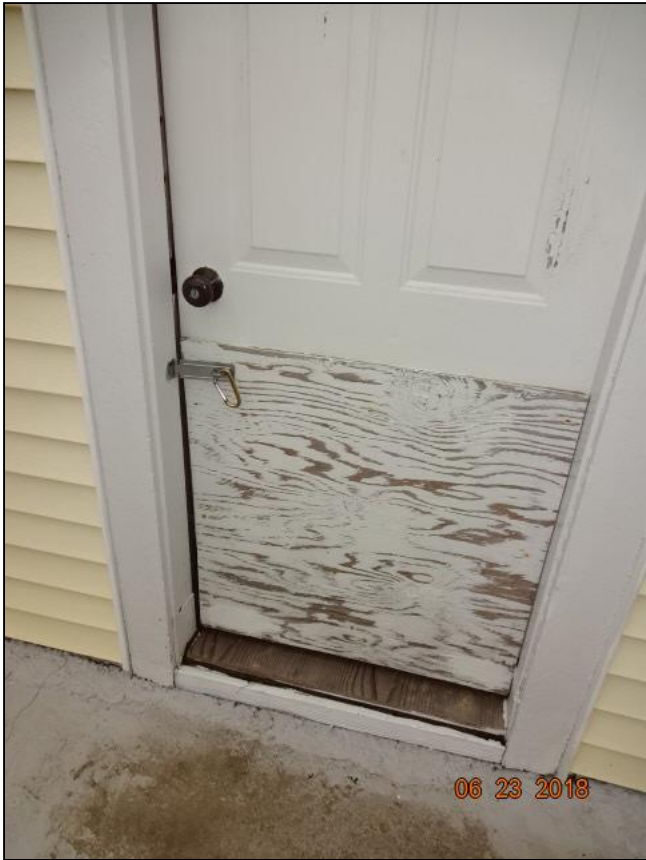
14.0.B Item 1(Picture)

⊘ Door is damaged.

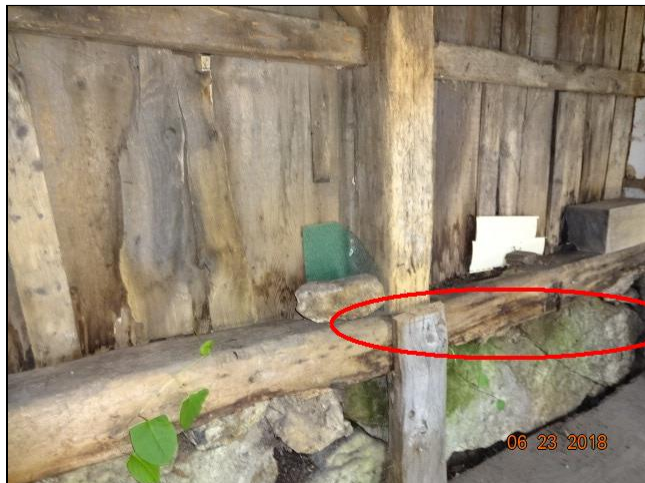
⊘ The back wall boarding is separated from the sill which is in a state of advanced decay. At some point late in the 19th century a summer kitchen was built inside this barn. Every aspect of the summer kitchen is in an advanced state of decay and very unsanitary. I recommend very careful removal of all of it to allow inspection and evaluation of the earlier barn structure.

14.2.B Item 1(Picture) damaged sill

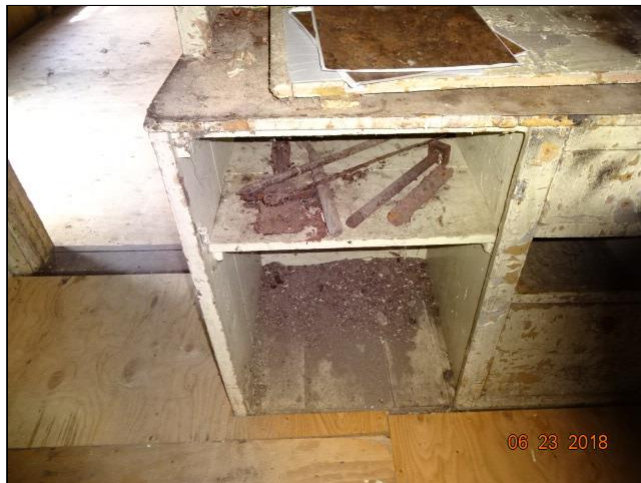
14.2.B Item 2(Picture) filth and rodent fecal matter

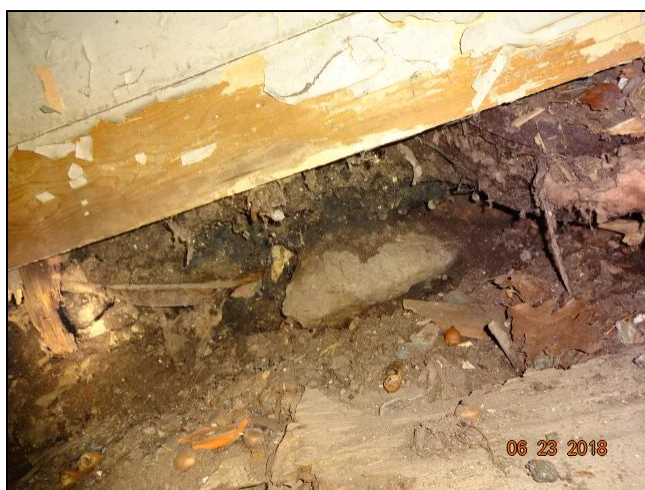
14.2.B Item 3(Picture) wall/floor junction

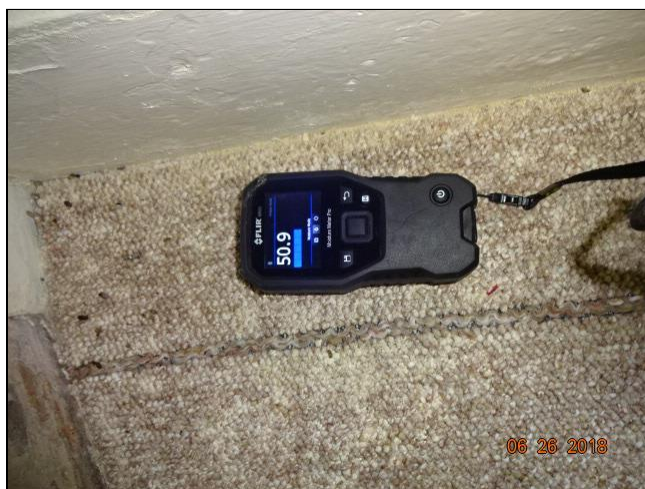
15.0 Item 1(Picture) High moisture meter reading

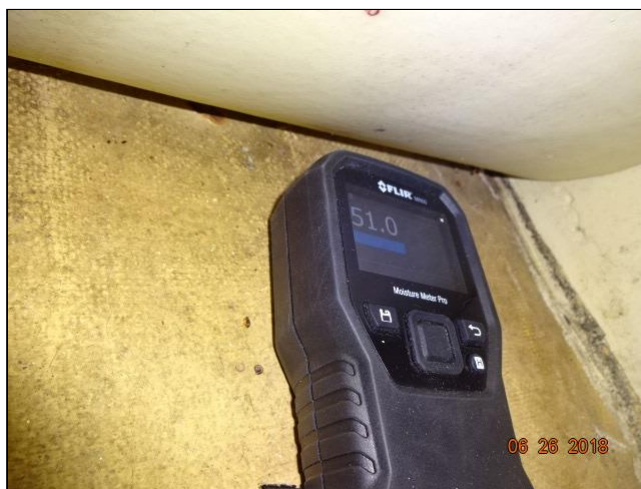
15.0 Item 2(Picture) High moisture meter reading

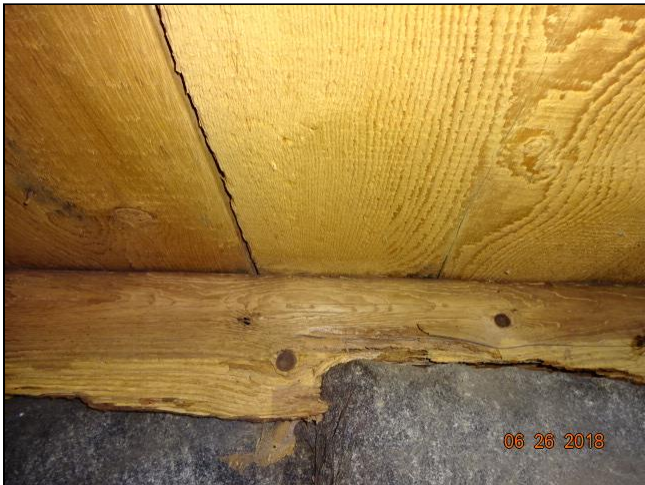
15.0 Item 3(Picture) Crushed sill at back wall

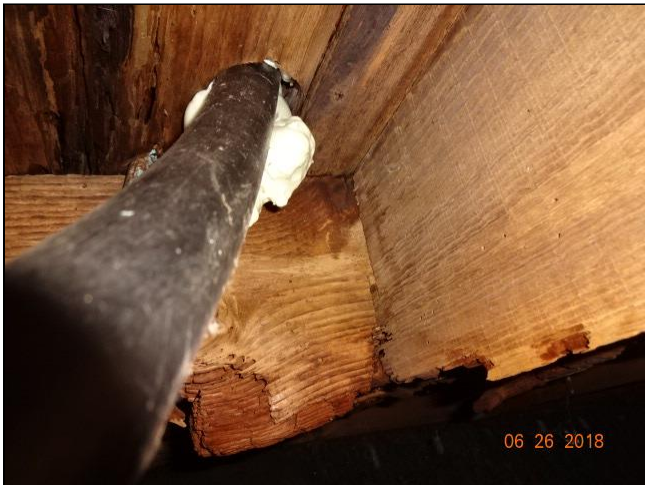
15.0 Item 5(Picture) Damaged joists and subfloor at washer drain

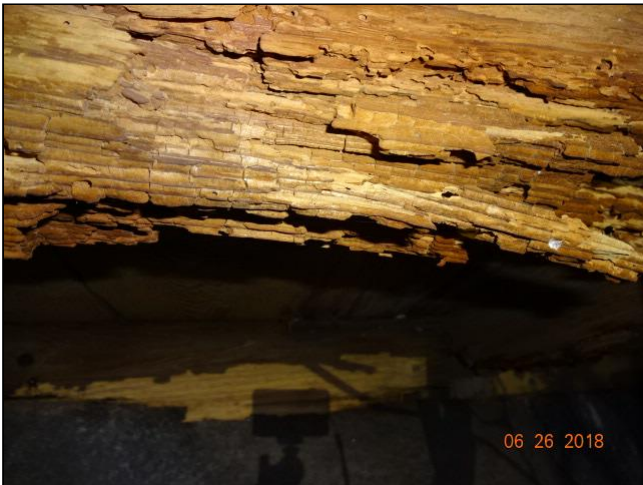
15.0 Item 6(Picture) Decayed joist

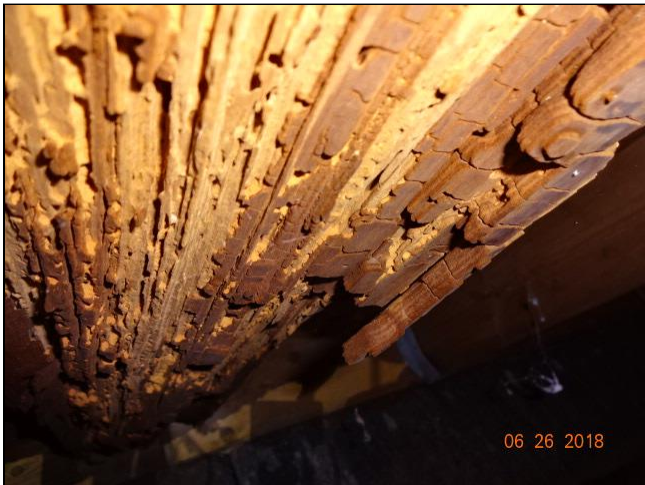
15.0 Item 7(Picture) decayed girder
