# Inspection Report

**Property Address:**  
123 Main St  
Midcoast Town Maine 04000

**Long Cove Inspections LLC**

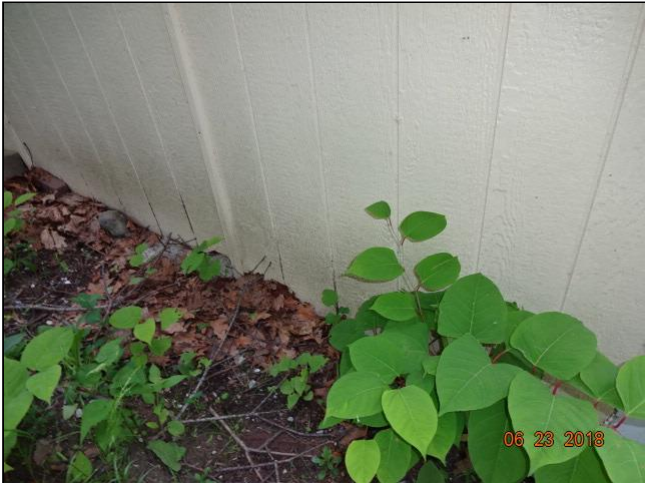
1.2 Item 2(Picture)

The grade at the rear and sides of both the house and barn should be lowered and graded to divert water. The sills are currently below grade in many areas.

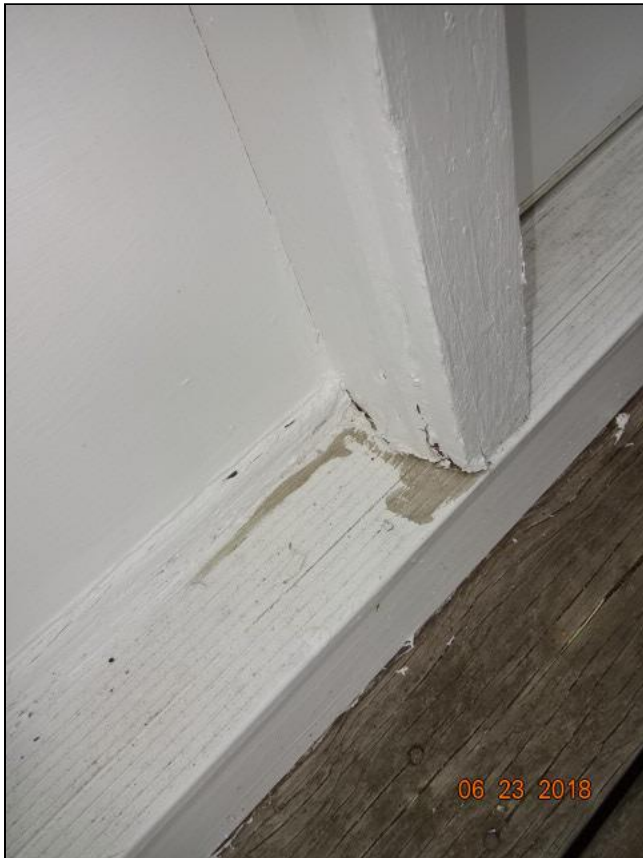
⊘ Damaged wood trim was observed at relatively few locations. Recent paint and putty may conceal other areas.

1.3 Item 2(Picture) southern entry

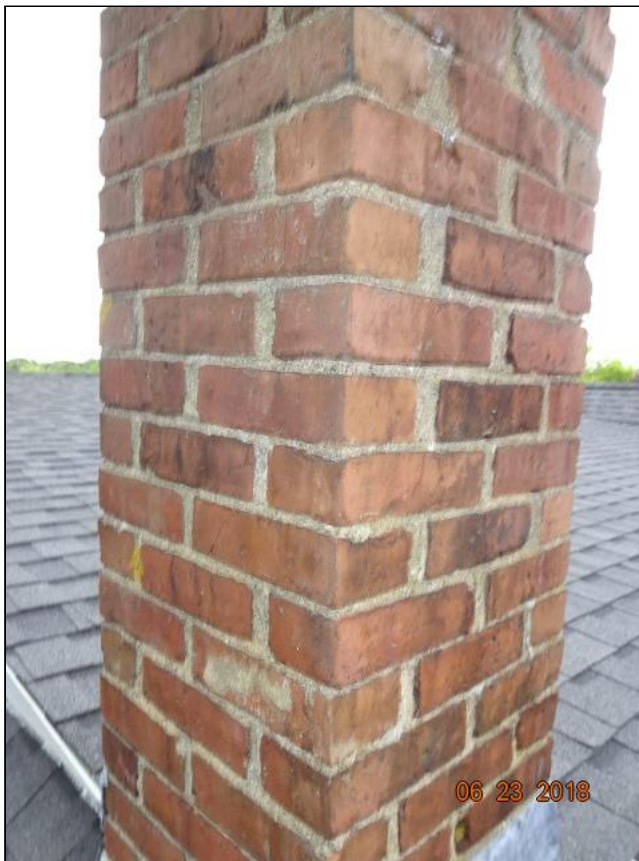
1.7 Item 2(Picture)

All four brick chimneys are unlined and weathered. Two serve as flues for oil fired furnaces and should be lined.

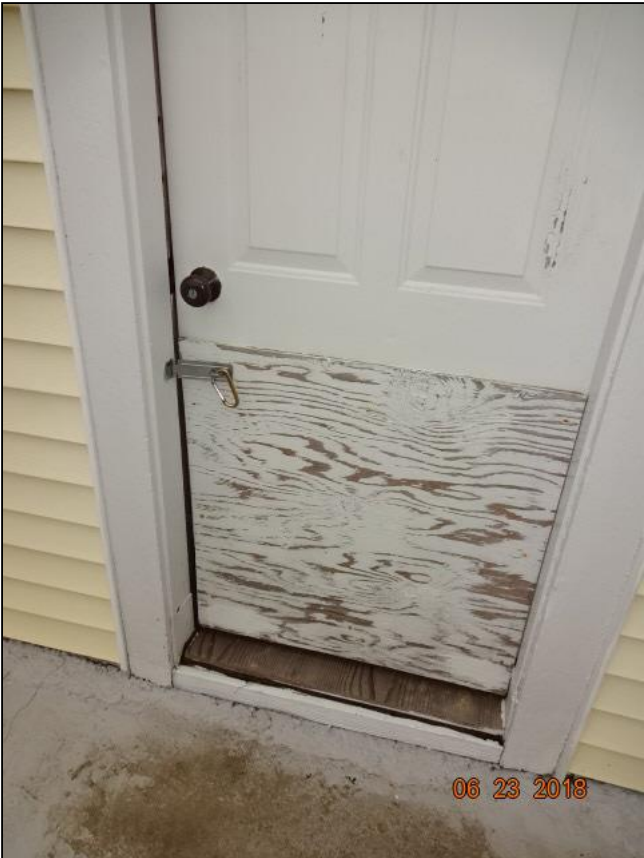
2.0 Item 2(Picture)

⛔ All six exterior doors require varying amounts of repair or adjustment. The entry unit with sidelights at the south side is in poor condition.

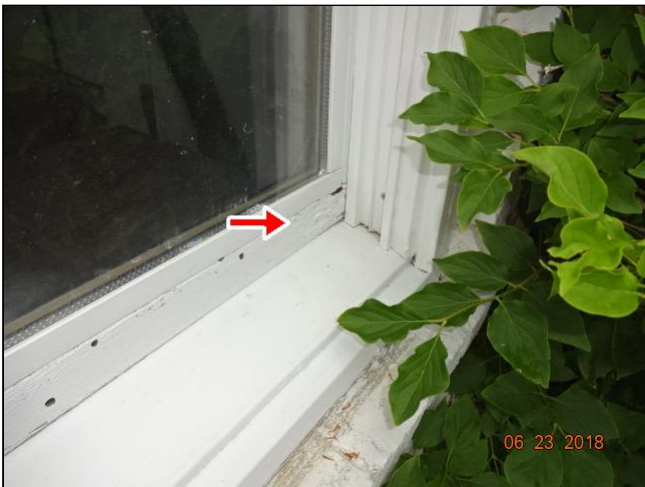
2.1 Item 2(Picture)

🔧 Several window sash particularly on the lowest level are showing signs of decay.

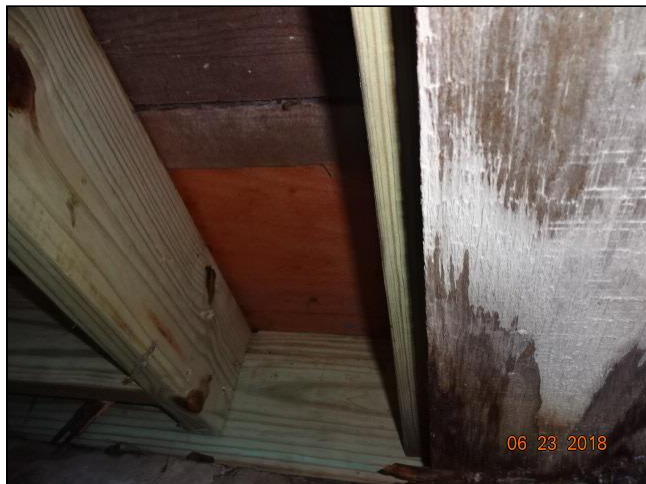
The southern covered entry has had repairs carried out underneath but the integrity of the southeast corner is questionable.

4.1 Item 5(Picture) south entry

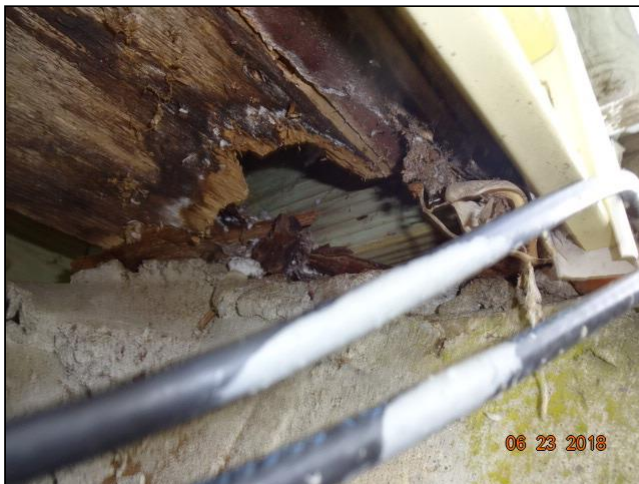
4.1 Item 6(Picture) entry,southeast corner

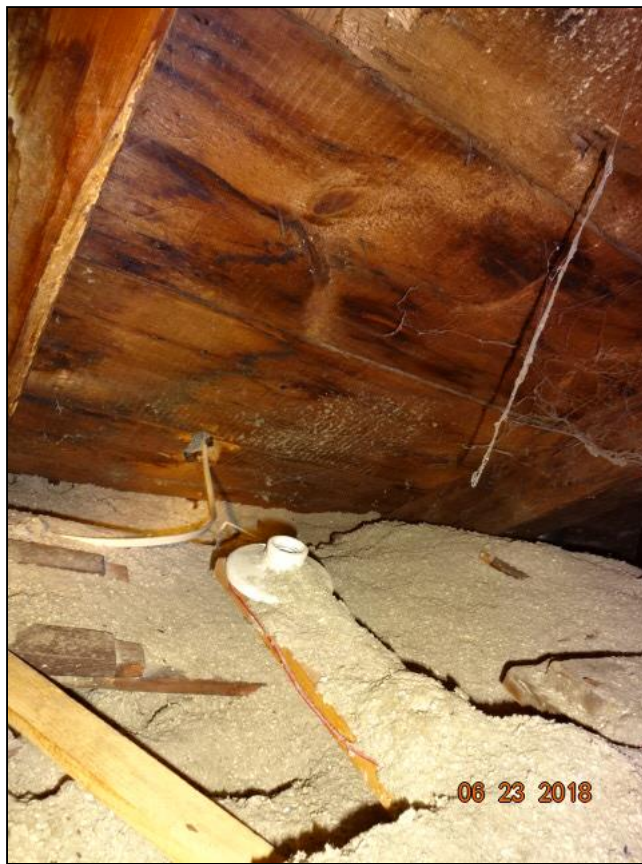
5.5 Item 1(Picture)

About six inches of cellulose insulation has been installed.

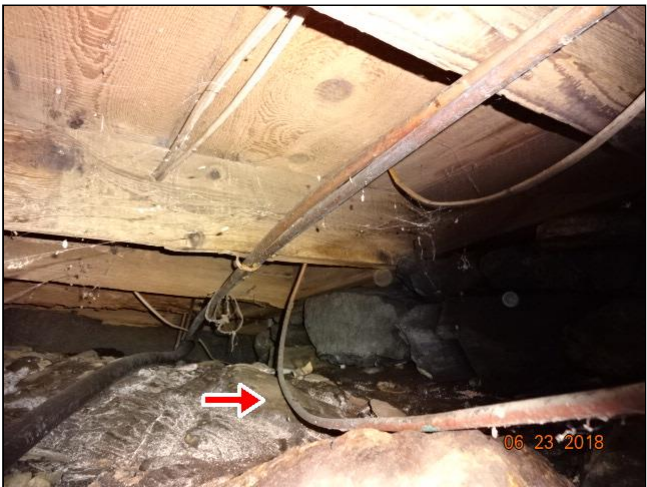
10.3 Item 2(Picture) washer drain rear laundry

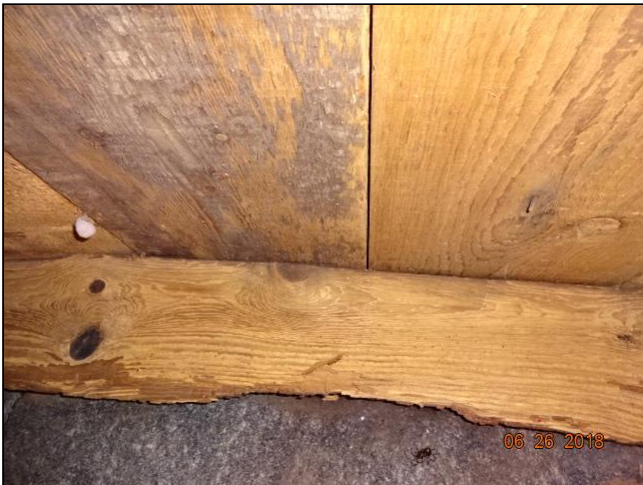
15.0 Item 4(Picture) Crushed sill at back wall

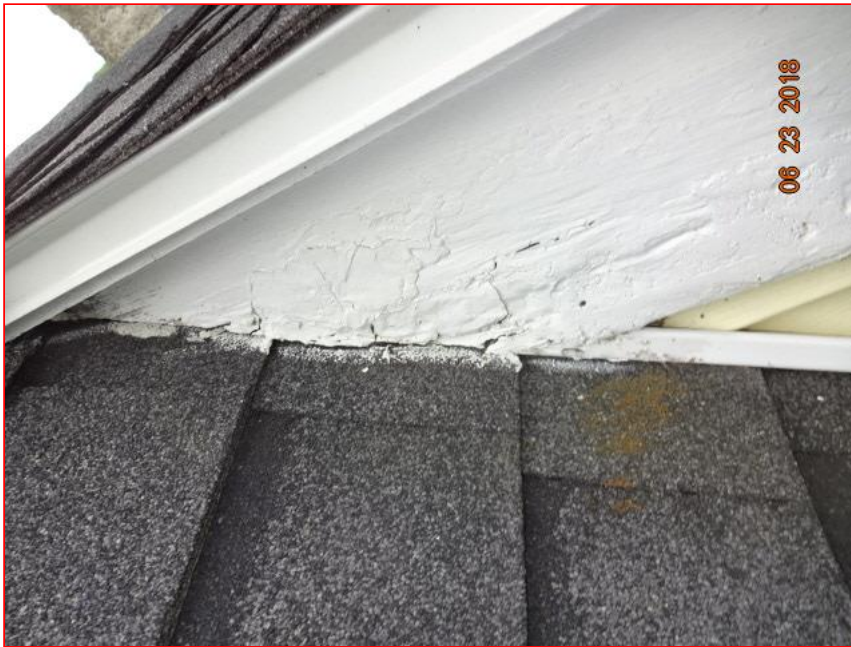
Damaged wood trim was observed at relatively few locations. Recent paint and putty may conceal other areas.

1.3 Item 1(Picture) rake board at flat roof

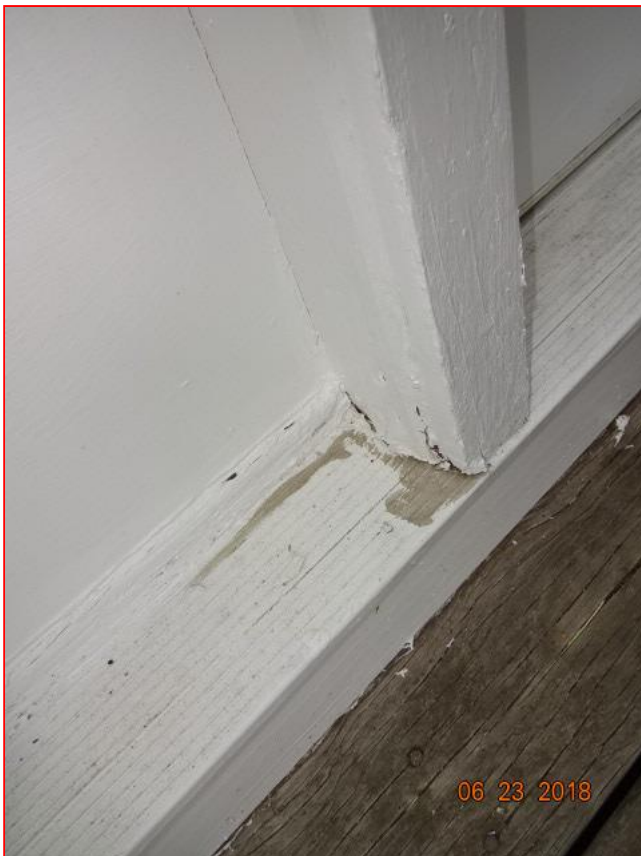
1.3 Item 2(Picture) southern entry

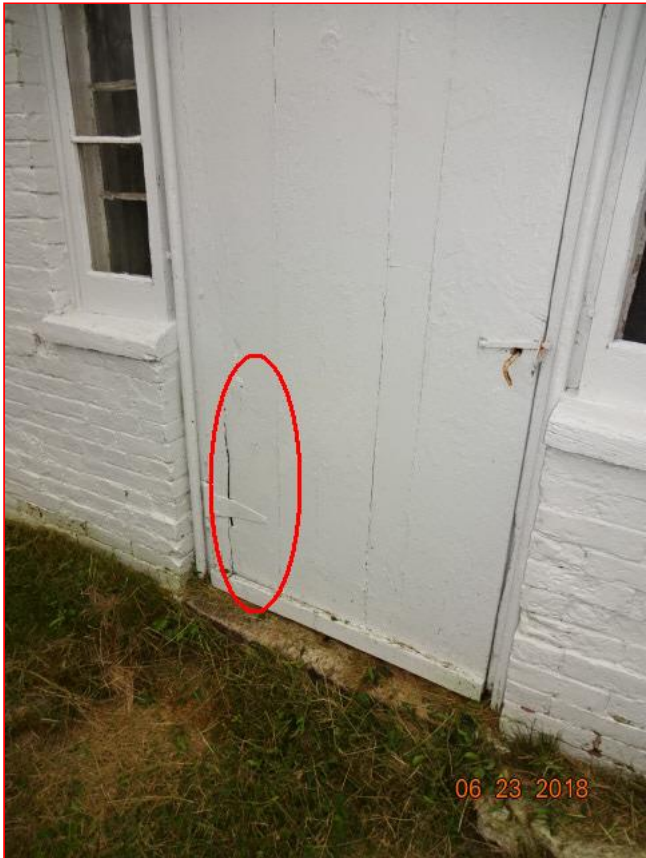
2.0 Item 1(Picture)

All six exterior doors require varying amounts of repair or adjustment. The entry unit with sidelights at the south side is in poor condition.

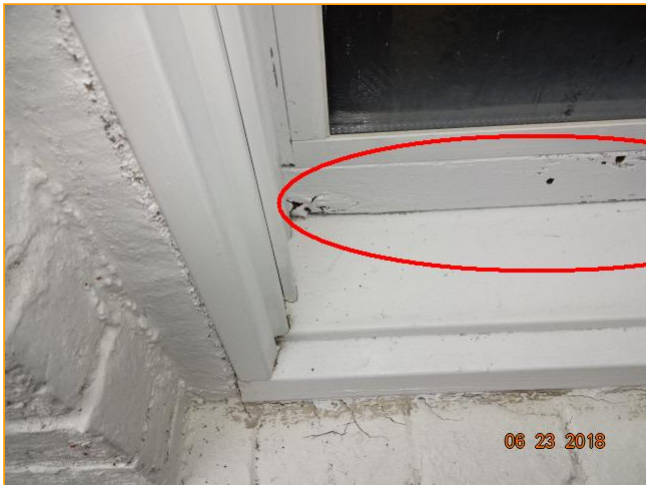
2.1 Item 1(Picture)

Several window sash particularly on the lowest level are showing signs of decay.

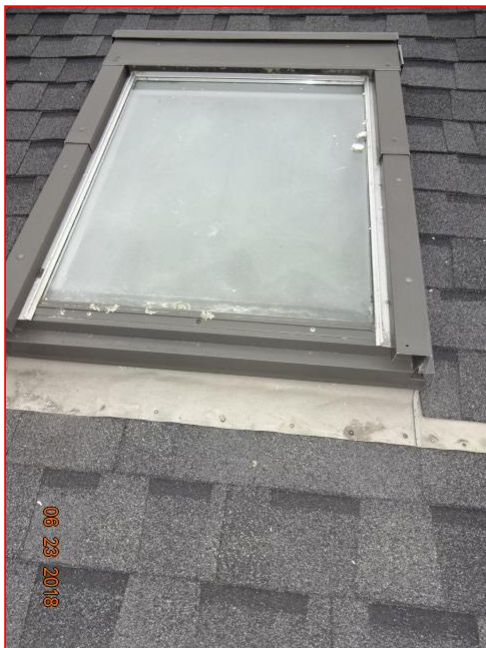
3.5 Item 1(Picture)

The glass in the skylight has a fogged seal.

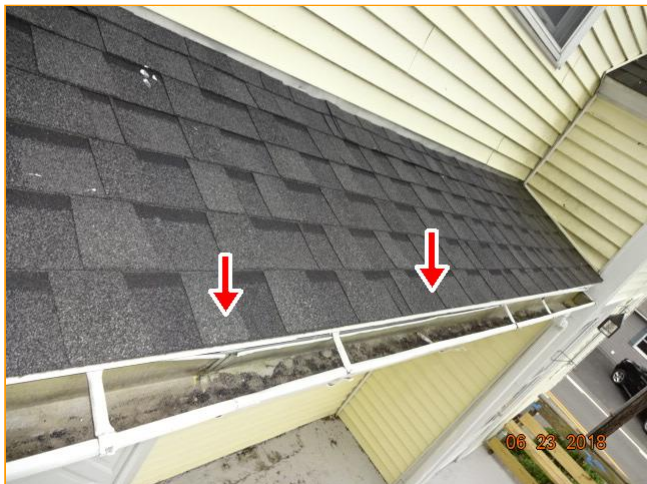
3.2 Item 1(Picture)

The gutter over the patio has some broken supports and needs cleaning. Additional guttering, particularly over the patio area and across the rear of the building is strongly recommended.

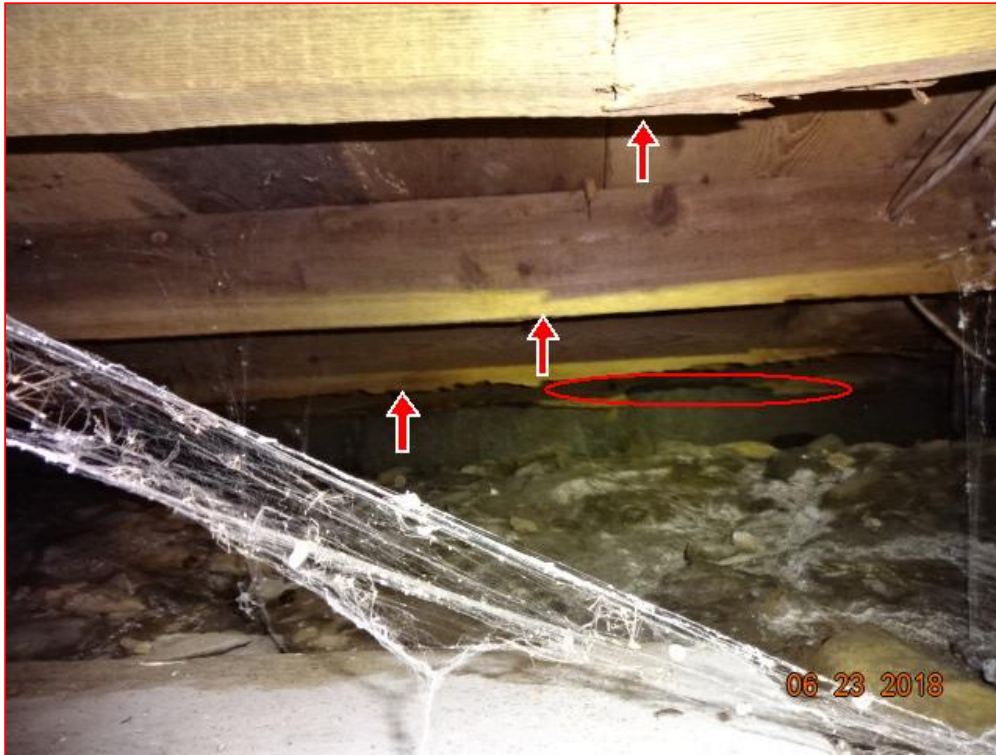
Although the joist system is generally in good condition for a building of this age, some damage to the floor joists and sills is suspected at the uphill end of the building. I could not get close enough to verify this but did take some pictures.

4.1 Item 1(Picture) damaged joists and possible bad sill (circled)

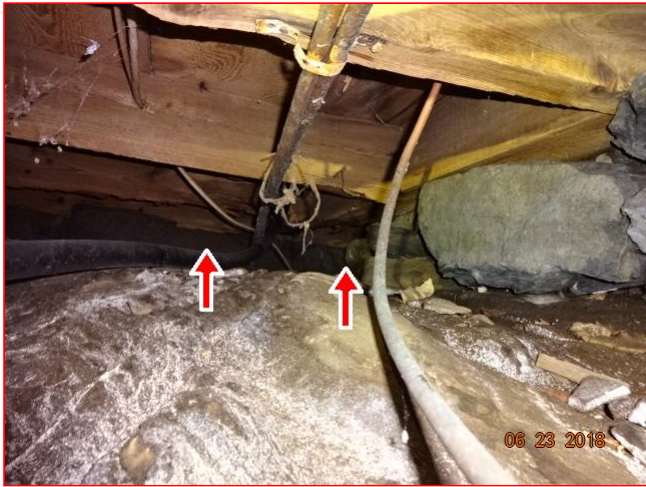
4.1 Item 2(Picture) area of suspected sill and beam damage.

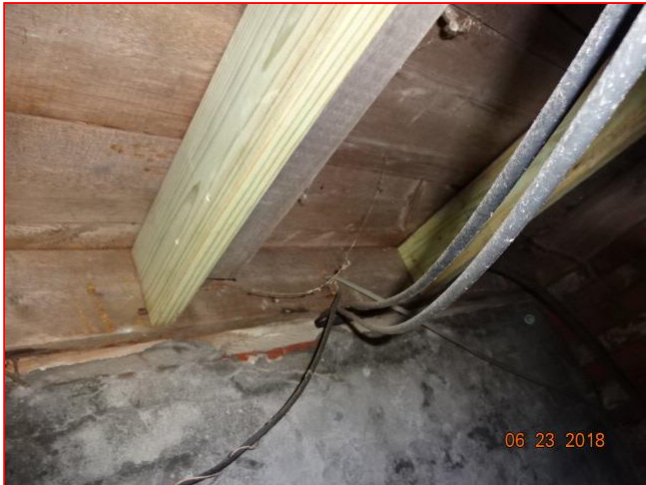
The southern covered entry has had repairs carried out underneath but the integrity of the southeast corner is questionable.

4.1 Item 4(Picture) under entry

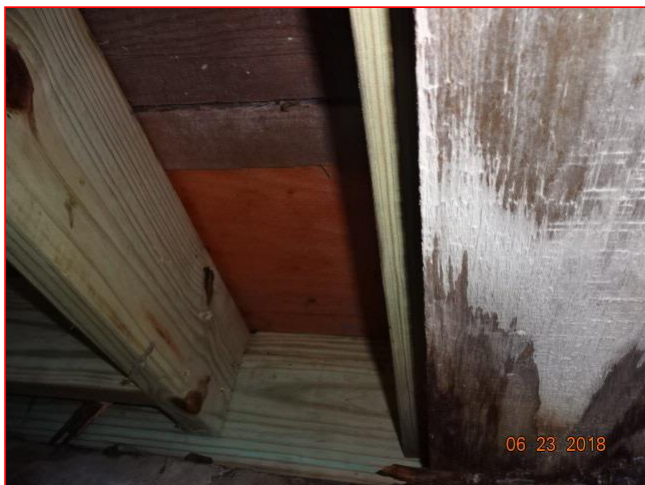
4.1 Item 5(Picture) south entry

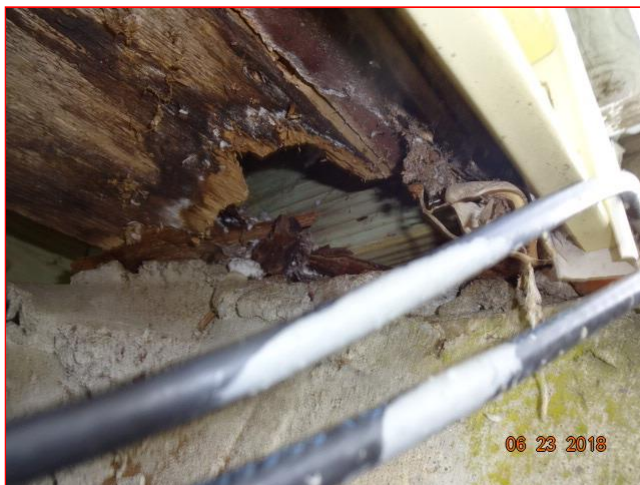
4.1 Item 6(Picture) entry,southeast corner

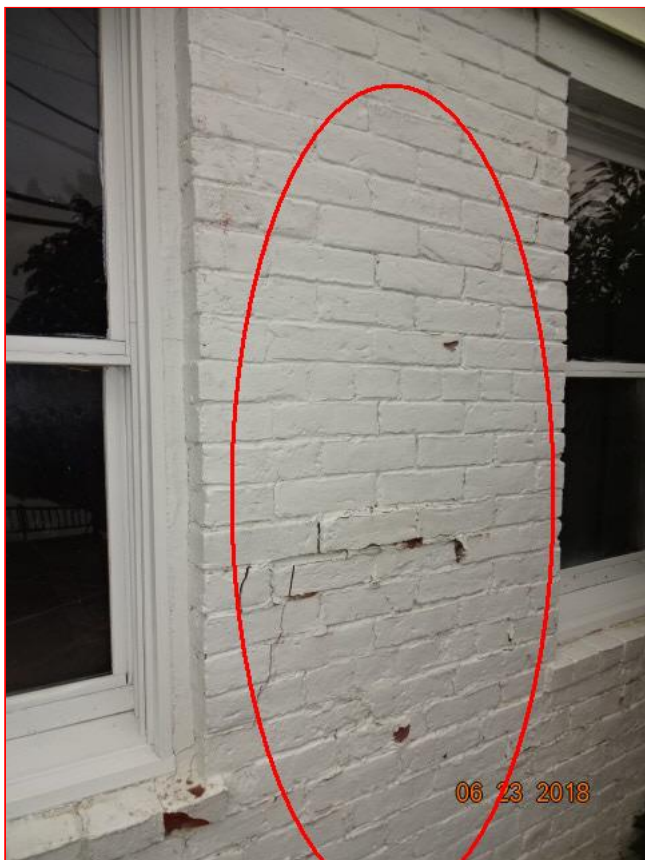
4.3 Item 1(Picture)

A series of cracks was noted in the brick wall at the lowest level. Repairs by a mason with experience in old buildings is advised.

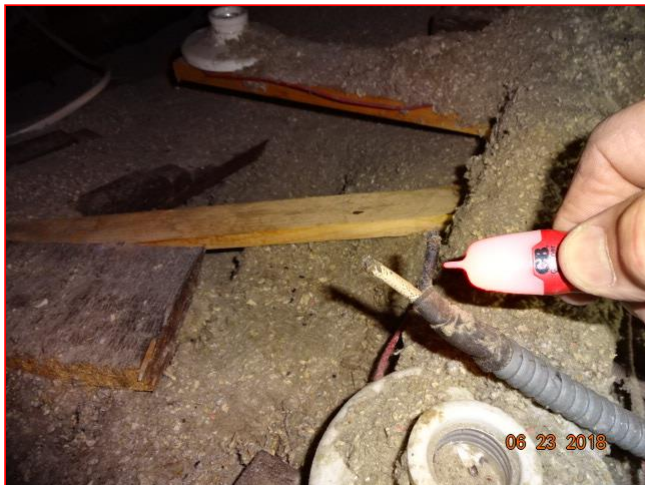
5.4 Item 1(Picture)

My tester indicated an exposed live wire just inside the hatch.

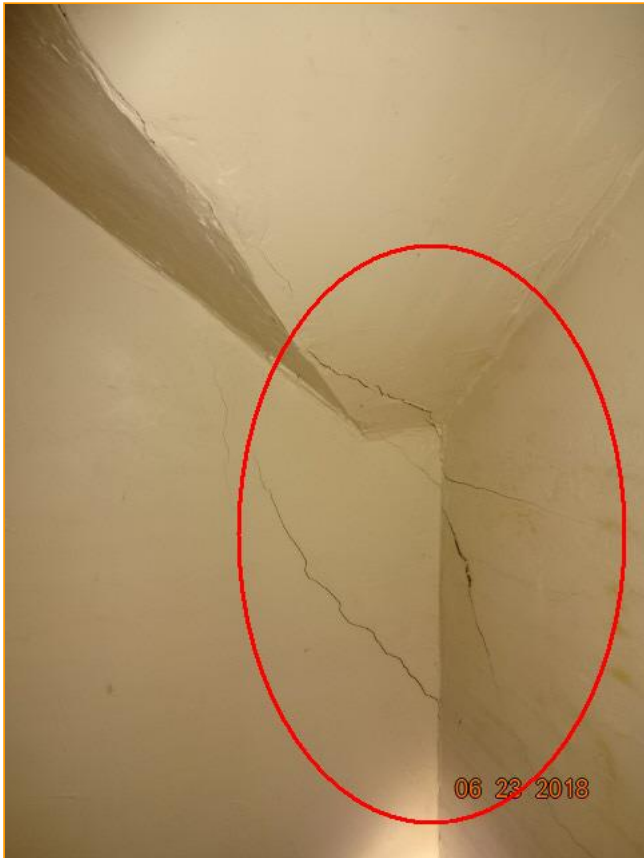
6.1 Item 1(Picture)

Some cracking of plaster walls at the east end on the second floor may indicate settlement. Suspected sill damage below is in the same general area.

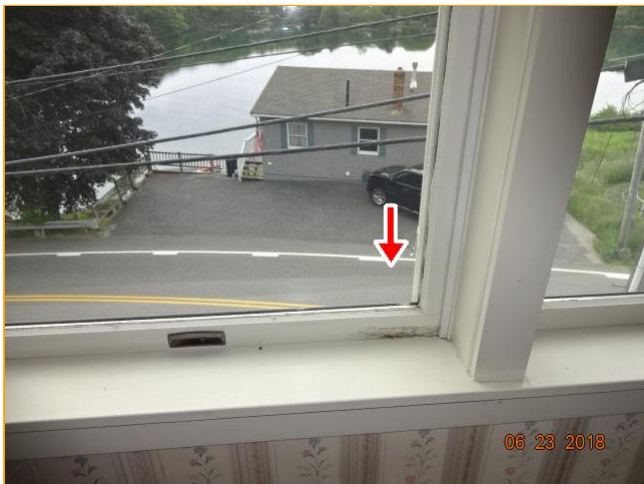
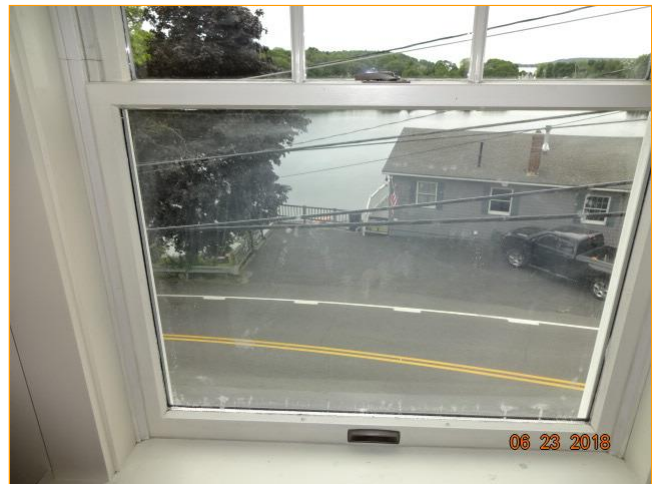
Windows on the east side are beginning to show decay at several locations. One sash has a fogged seal on the second floor.

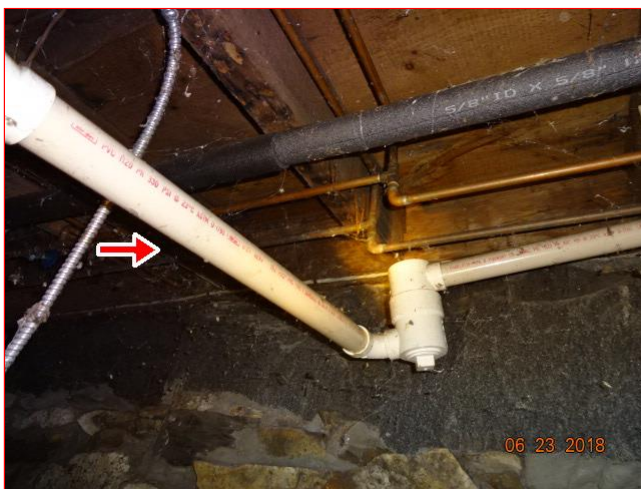
The washer drains are not compliant with modern codes: Both have low sections where water is retained at all time and the rear unit runs through plastic pipe about 20' and then uphill to a drum trap.

10.3 Item 1(Picture) direction of water flow front laundry drain

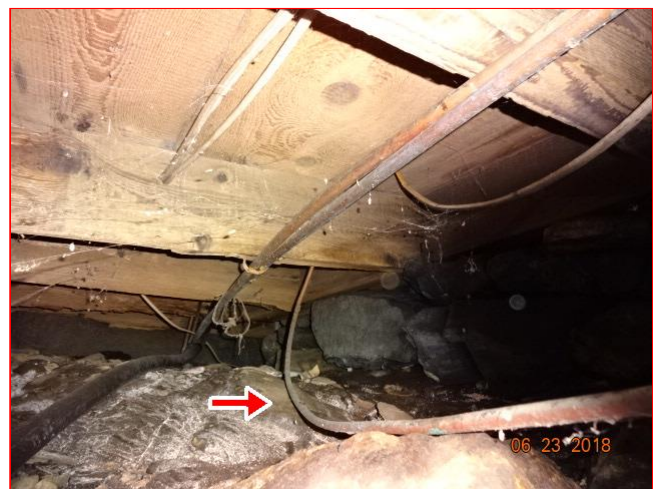
10.3 Item 2(Picture) washer drain rear laundry

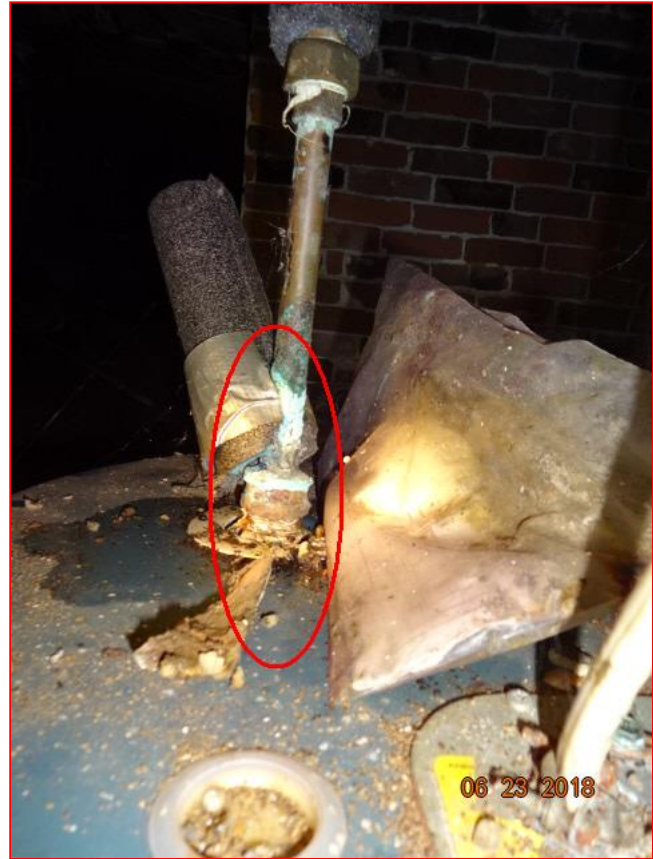
Each unit has an electric water heater. Both should have the relief piping extended closer to the floor. The Richmond heater with the six year warranty was installed in 2007 and shows signs of deterioration at the top. The other by US Craftsmen appears to be in good condition.

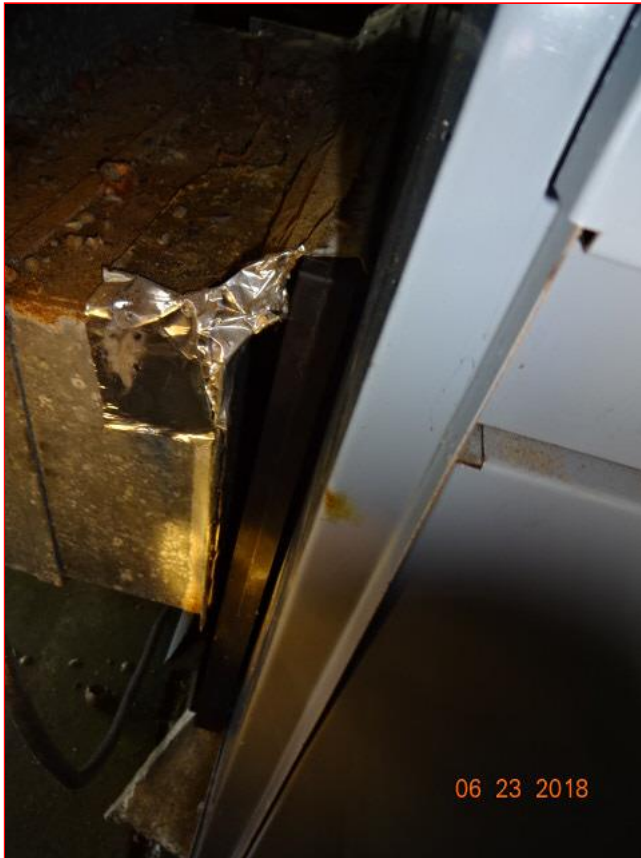
Two furnaces were tested: an older Williamson temp-o-matic in the rear unit and a recently installed 2011 Airco unit for the front. The Airco unit has a poorly crafted return air filter box. The Williamson unit is an older unit. I could not determine its age but Williamson went out of business in the 1990s. They made a great product but the age of the unit should be considered. I put a CO detector in front of a register at each unit and got no reading but a test by a certified heating tech is recommended.

11.0 Item 1(Picture) Airco return air filter

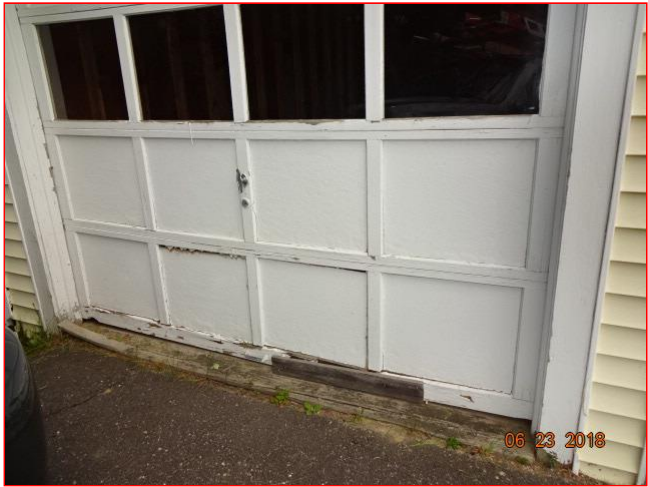
14.0.A Item 1(Picture) damaged door (1 of 2)

The doors need to be replaced.

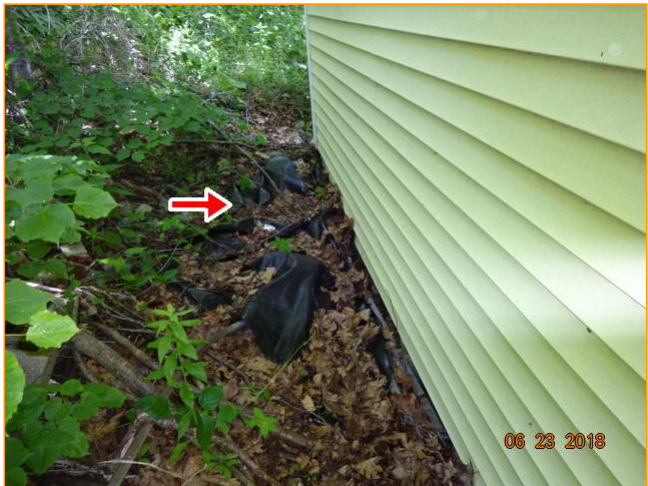
14.3.A Item 1(Picture)

The structure is in overall good condition, but the southeast corner is below grade. Excavation and re-grading is needed. It may be desirable to install a gutter and downspout on the east side to direct water away from the corner of the building. Overhanging trees should be cut away.

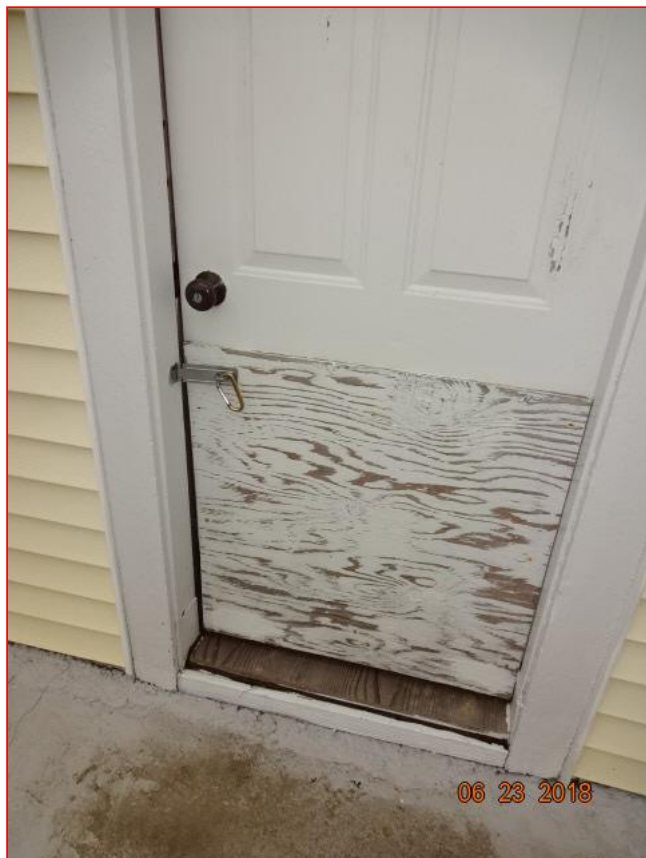
14.0.B Item 1(Picture)

Door is damaged.

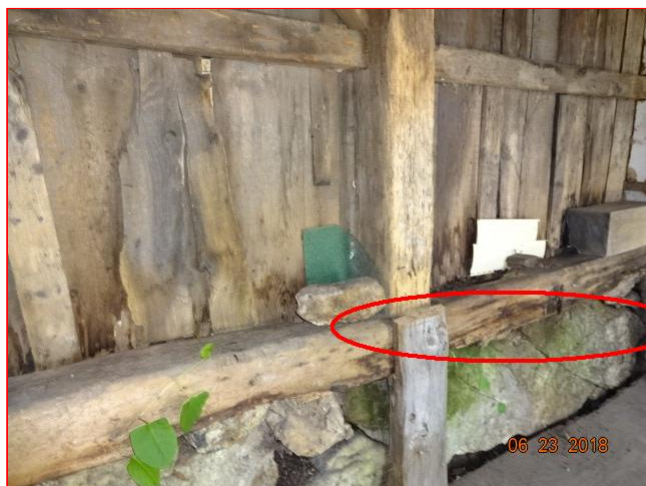
The back wall boarding is separated from the sill which is in a state of advanced decay. At some point late in the 19th century a summer kitchen was built inside this barn. Every aspect of the summer kitchen is in an advanced state of decay and very unsanitary. I recommend very careful removal of all of it to allow inspection and evaluation of the earlier barn structure.

14.2.B Item 1(Picture) damaged sill

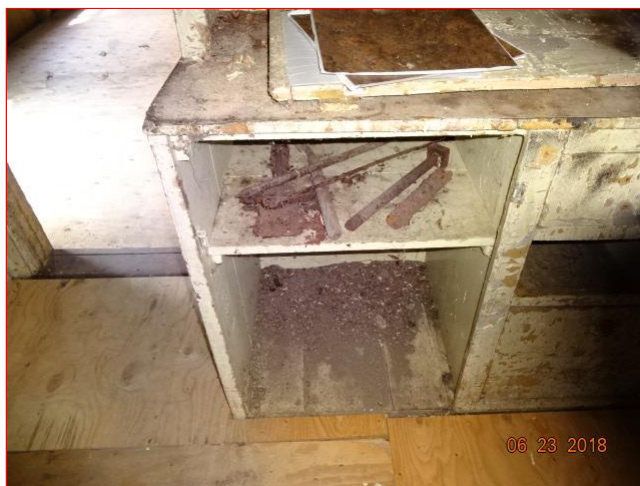
14.2.B Item 2(Picture) filth and rodent fecal matter

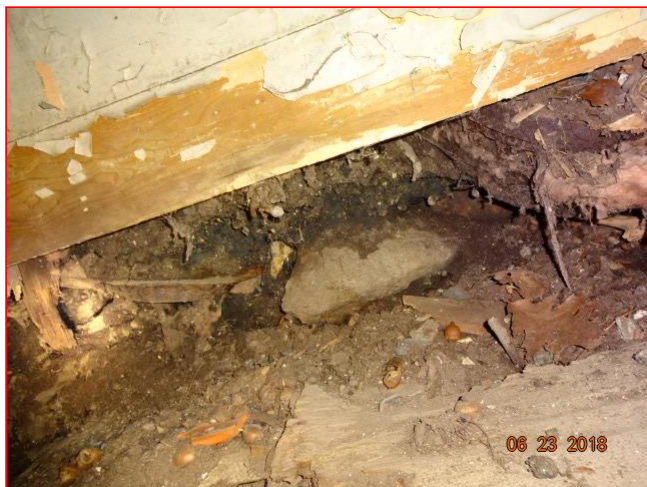
14.2.B Item 3(Picture) wall/floor junction

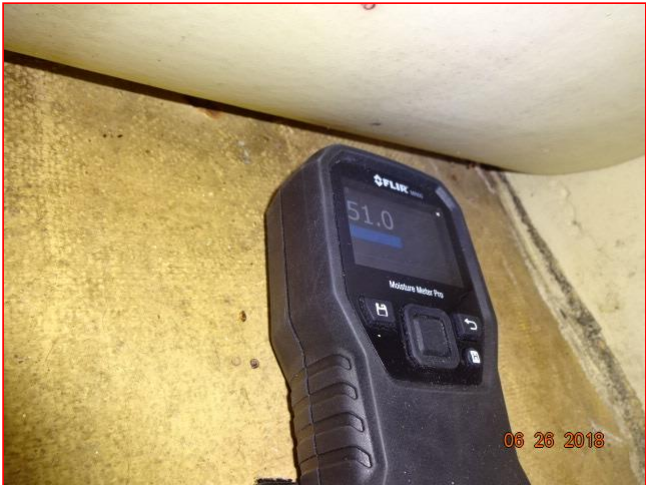
15.0 Item 2(Picture) High moisture meter reading

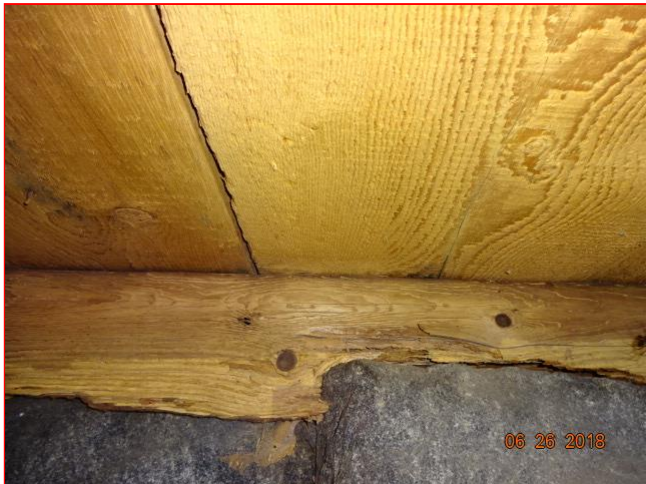
15.0 Item 3(Picture) Crushed sill at back wall

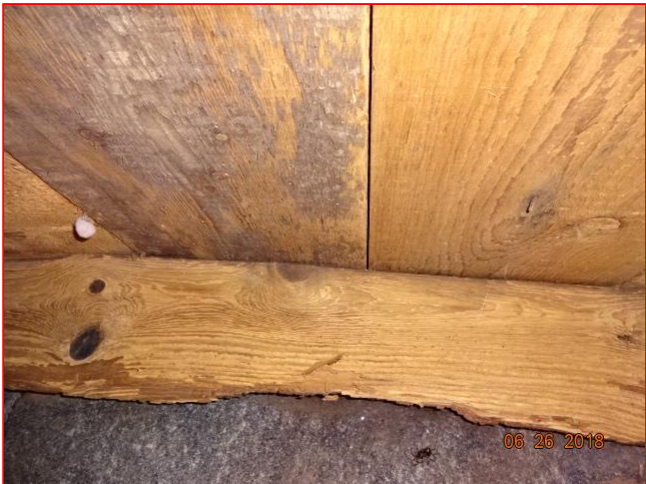
15.0 Item 4(Picture) Crushed sill at back wall

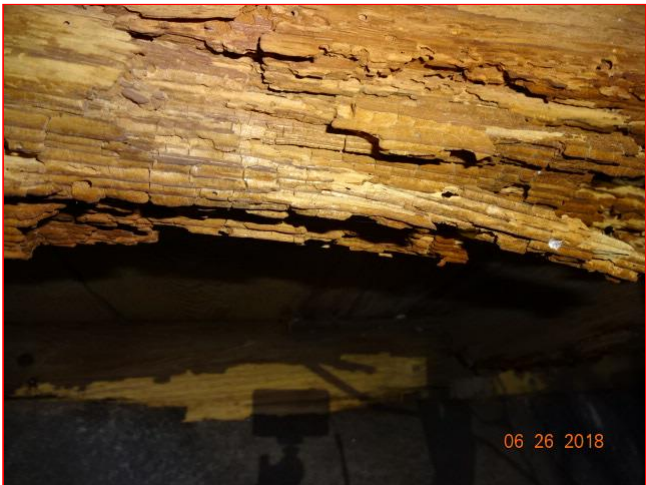
15.0 Item 6(Picture) Decayed joist

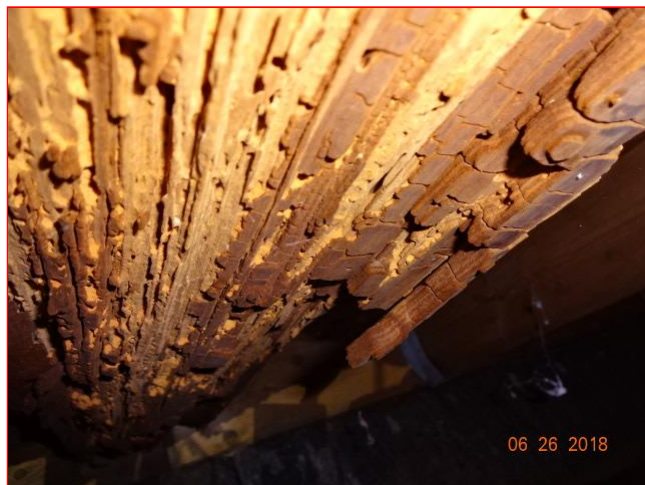
15.0 Item 7(Picture) decayed girder
